PWM NOISE IMPROVEMENT FOR RFX-8140

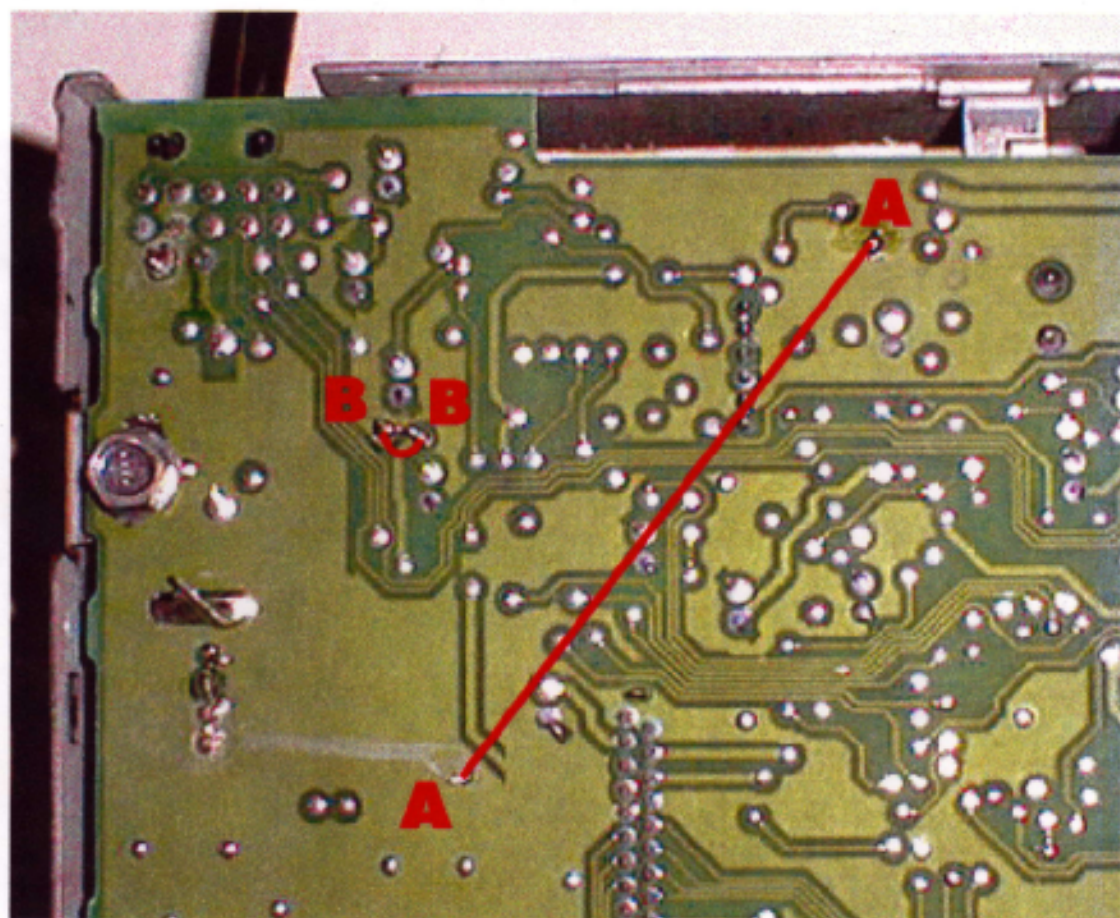
Improving PWM Noise which occurs when the illumination wire is connected to +12V requires adding two jumper wires on ground traces or ground plane. Both jumpers will be connecting grounds together, so verify that all points on the circuit board that are going to be soldered are shorted to the chassis of the radio by measuring the resistance from that point to the chassis. This will verify that you have chosen the correct locations.

1. Remove the bottom cover of the source unit and using the above photo locate the two Vias labeled "A" (these two vias are near the RCA connector). Verify that these two vias are both connected to ground with an Ohm meter.
2. Connect a jumper wire (18 gauge minimum) between these two vias.
3. Locate the Via and trace labeled "B". Verify these are ground, then connect a jumper wire between these two vias.
4. Replace the cover securely and have a cold one.
